Manhole Inspection Summary

Manhole # S19E__010MH

Insp Date: **4/24/09 2:15 PM**

Location Address: **214 PULASKI-PAYSON**

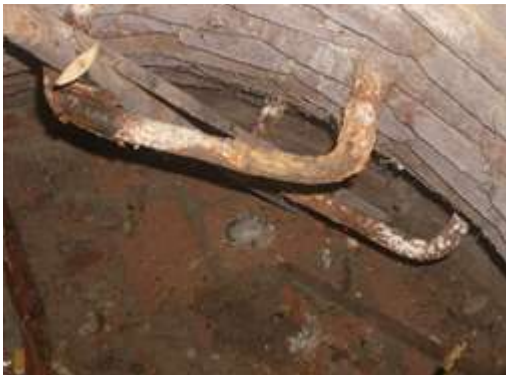
Defect 2

Steps Count: **2** Missing: **0** ☒ **Corroded**

CORRODED STEPS

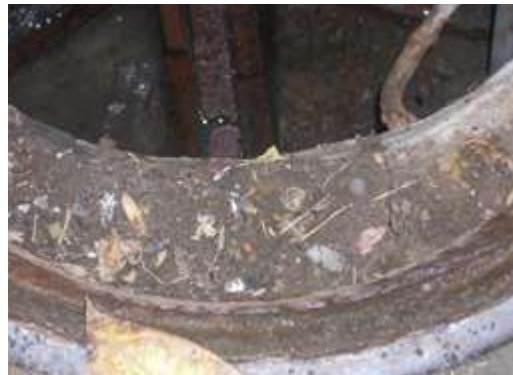
Defect 1

Frame Offset: **5** (in.) Condition: ☒ Sound ☐ Cracked ☐ Leaks

FRAME OFFSET

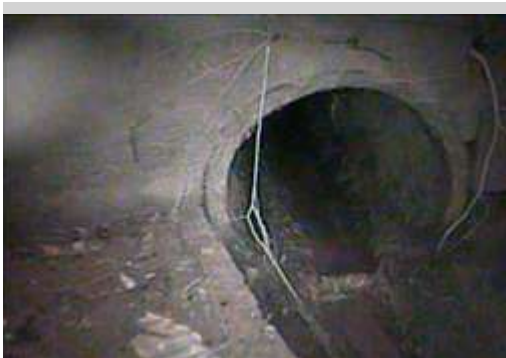
Defect 3

Condition: ☐ Sound ☐ Cracked ☒ **Root Intrusion** ☐ Loose Brick ☐ Deteriorated

ROOT INTRUSION

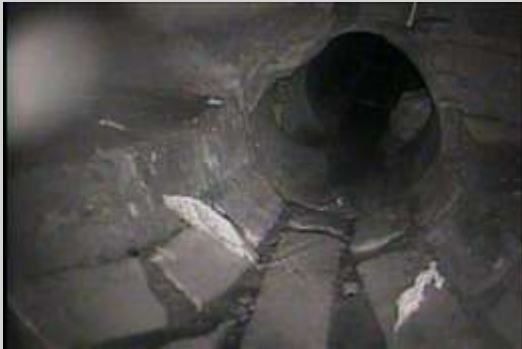
12 O'Clock Outflow

8 in. Circular Gravity Sewer
Pipe Out @ 12 O'Clock

Pipe Height: **8.4** (in.) Rod and Bar (Angled)
Pipe Material: **Clay** ☐ Pipe Lined
Invert Depth: **6.02** (ft.) Flow Characteristics: **Slow**
Deposits: ☒ None ☐ Mud ☐ Sludge ☐ Debris ☐ Grease
Silt Depth: (in.) Deposits Extent:
Infiltration: **None** Pipe Seal Cond: **Sound**

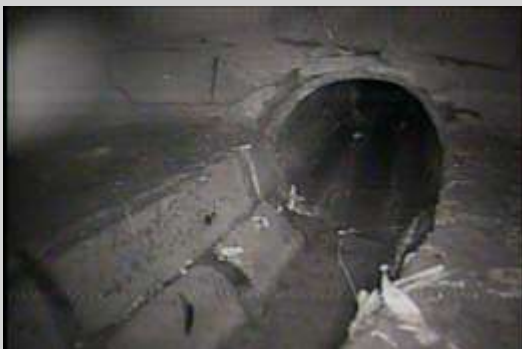
3 O'Clock Inflow

6 in. Circular Gravity Sewer
Pipe In @ 3 O'Clock

Pipe Height: **6** (in.) Rod and Bar (Angled)
Pipe Material: **Clay** ☐ Pipe Lined
Invert Depth: **5.73** (ft.) Flow Characteristics: **Slow**
Deposits: ☒ None ☐ Mud ☐ Sludge ☐ Debris ☐ Grease
Silt Depth: (in.) Deposits Extent:
Infiltration: **None** Pipe Seal Cond: **Sound**

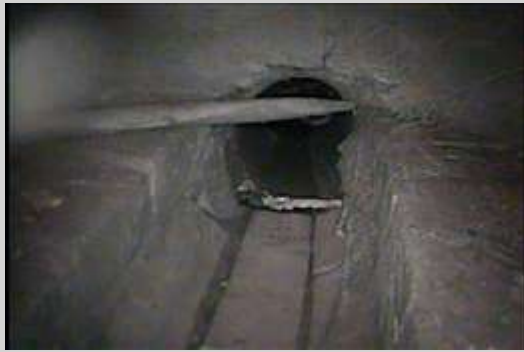
6 O'Clock Inflow

6 in. Circular Gravity Sewer

Pipe In @ 6 O'Clock

Pipe Height: **6** (in.) Rod and Bar (Angled)

Invert Depth: **5.55** (ft.) Flow Characteristics: **None**

Infiltration: **None** Pipe Seal Cond: **Sound**

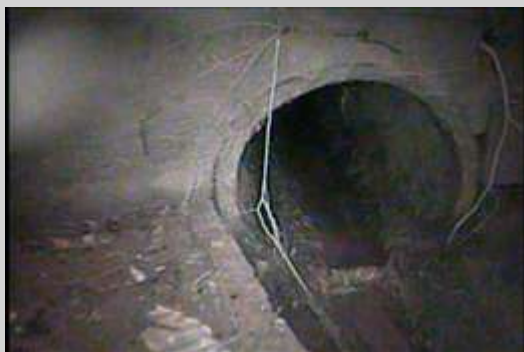
9 O'Clock Inflow

8 in. Circular Gravity Sewer

Pipe In @ 9 O'Clock

Pipe Height: **8.4** (in.) Rod and Bar (Angled)

Invert Depth: **5.62** (ft.) Flow Characteristics: **Slow**

Infiltration: **None** Pipe Seal Cond: **Sound**
